Report of Release of K-25 Process Materials

INVESTIGATING COMMITTEE REPORT
OF SERIOUS INCIDENT
INVOLVING RELEASE OF K-25 PROCESS MATERIALS

KS-331

Location of Incident: Cold Trap Room, K-1131 Feed Plant, Carbide and Carbon Chemicals Company, K-25 Plant, Oak Ridge, Tennessee.

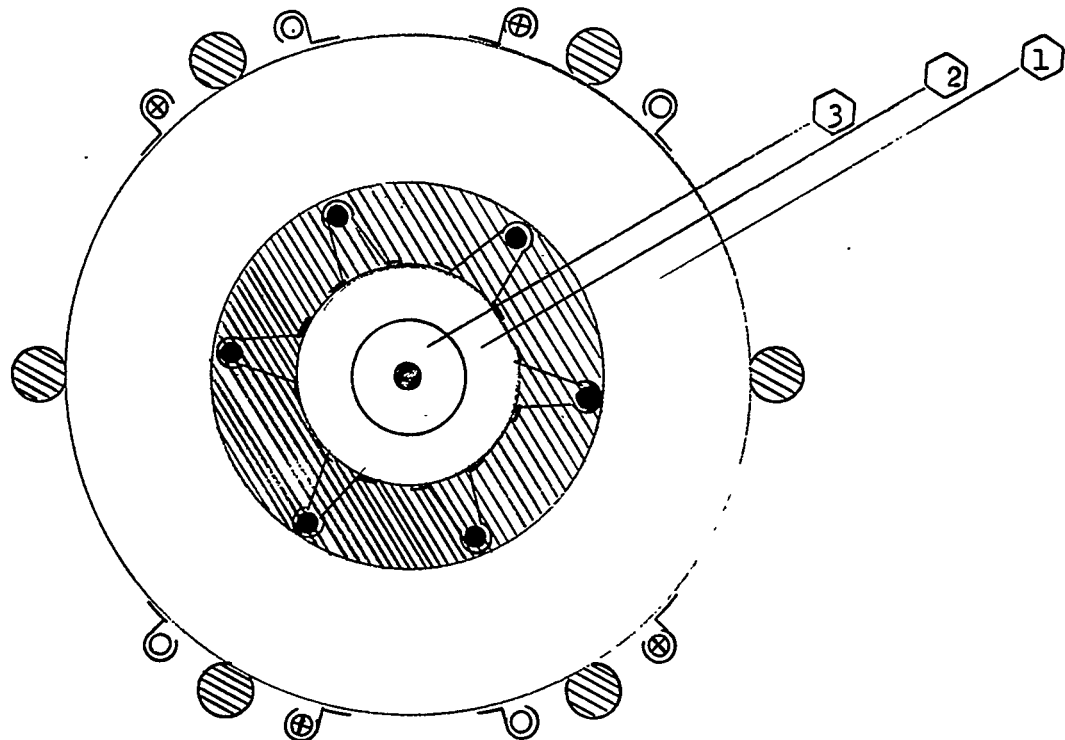
CROSS SECTION VIEW OF COLD TRAP

- (b) The original "triple-pass" design of the cold trap called for heating units inside the trap as shown on the attached diagram of the cross section of the trap. However, as a result of the recent increased use of these heaters in phase II of Feed Plant operations, the plant reserve has been exhausted, and although additional heaters of this type have been on order since November 1951, none have been delivered as the original vendor has now encountered difficulty in meeting the specifications. Thus, in September 1952 it became necessary to devise a substitute heating method which involved doubling the number of heating units placed outside the trap.

- (c) Overpressure alarms were available. However, due to frequent operation above the alarm pressure of 40 psig., these had been made ineffective.
6. The rupture consisted of a 1-1/2" long longitudinal crack under one of the clips holding one of the original calrod heating units close to the trap surface. Although the original specification had required a thermal insulator between the calrod unit and the clip, such insulation had not been applied in this case. Also, the clip was designed to hold the heater approximately 9/16" from the trap surface, but inspection at the time of discovery of the crack indicated that in some way it had been so pinched that the calrod was in contact with the trap shell. The description of the calrod units included a surface temperature specification of about 500°F.
